HISTORIC STRUCTURE REPORT

Lear Theater

City of Reno | October 18, 2024

Lear Theater Structural Condition Assessment

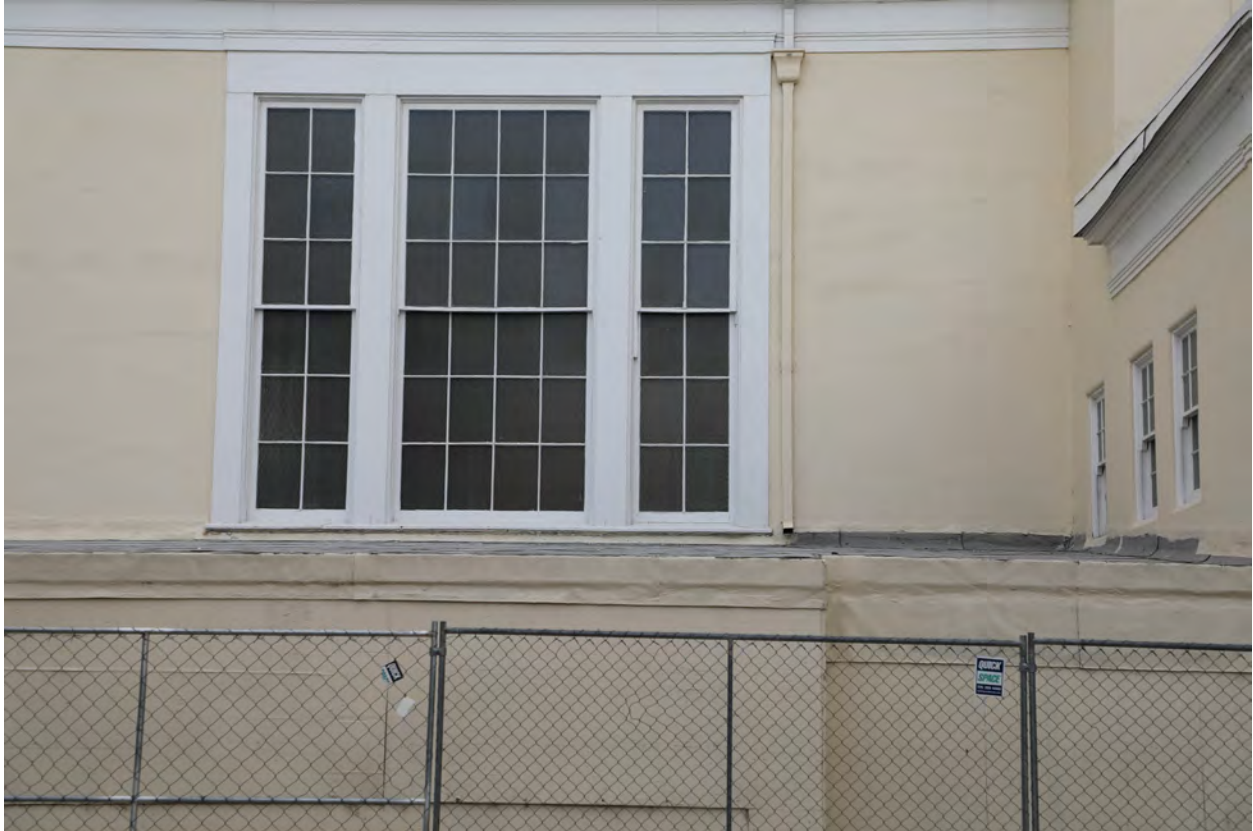
Figure 14 - West facade, looking at large window above temporary structure enclosing incomplete 2002 addition (ARG, 2024)

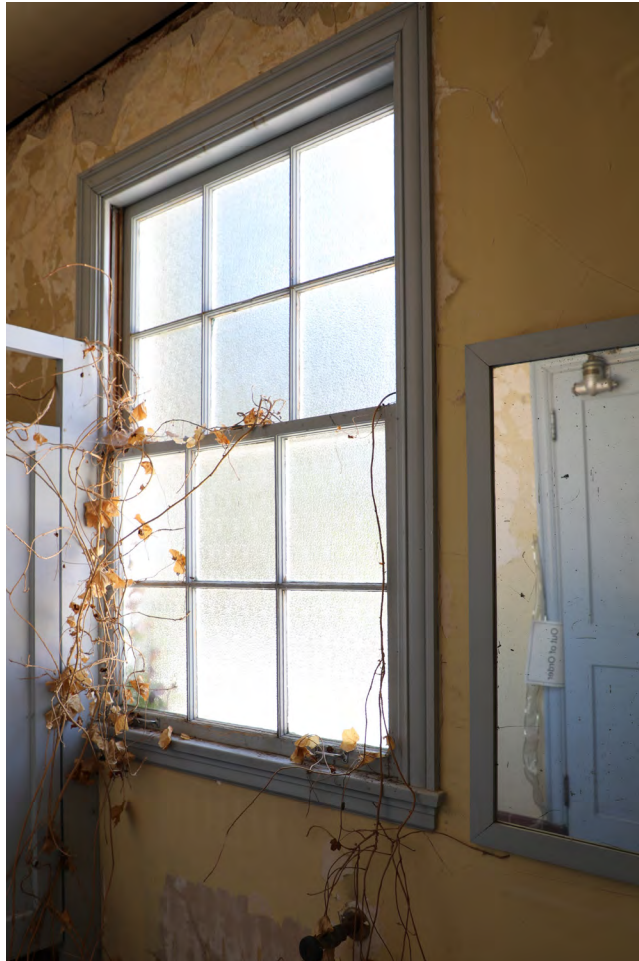
Figure 26 - Looking at plant growth through window in west restroom, view southwest (ARG 2024)

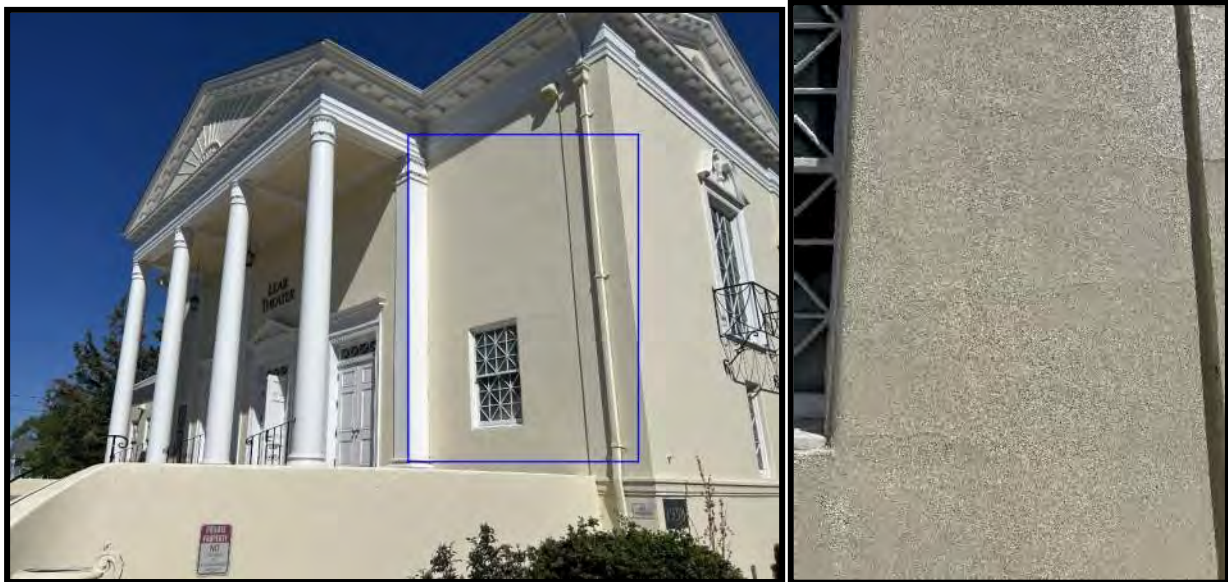
Overall, the interior and exterior wall framing appears to be in good condition. A few hairline cracks were observed in the south entrance wall finish (**Figure 25**), and in the southern room finishes (see **Figure 26** and **Figure 27**). Given the size, these cracks are likely only in the wall finishes and are not a significant structural concern.

Figure 25 View of cracking in the exterior wall finishes from further away (left) and close up (right) at the south theater entrance.

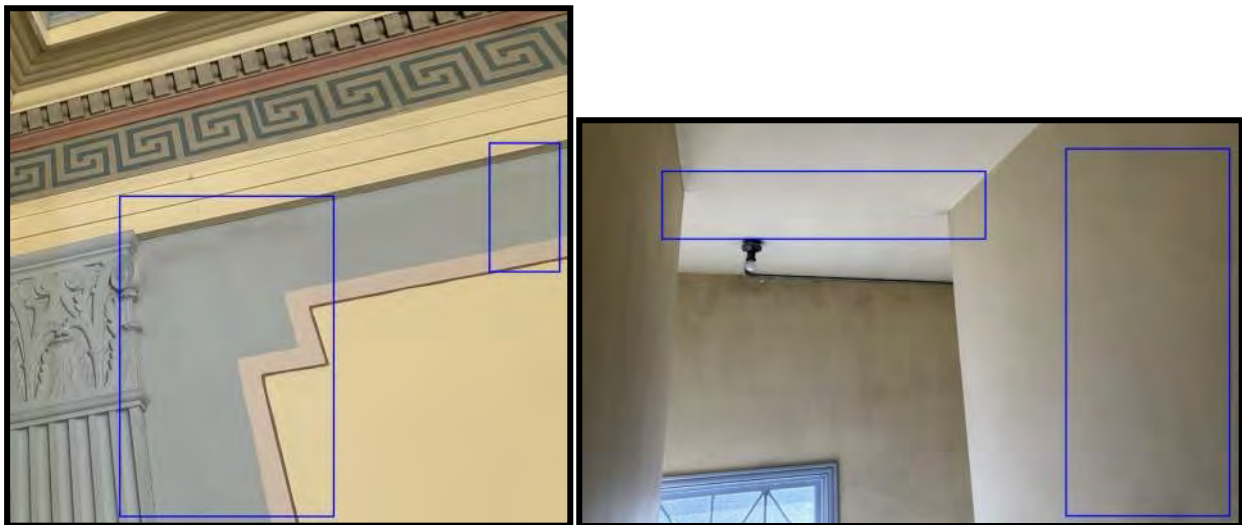
Figure 27 View of hairline cracks in the second-floor rooms and stairways highlighted in the previous figure.

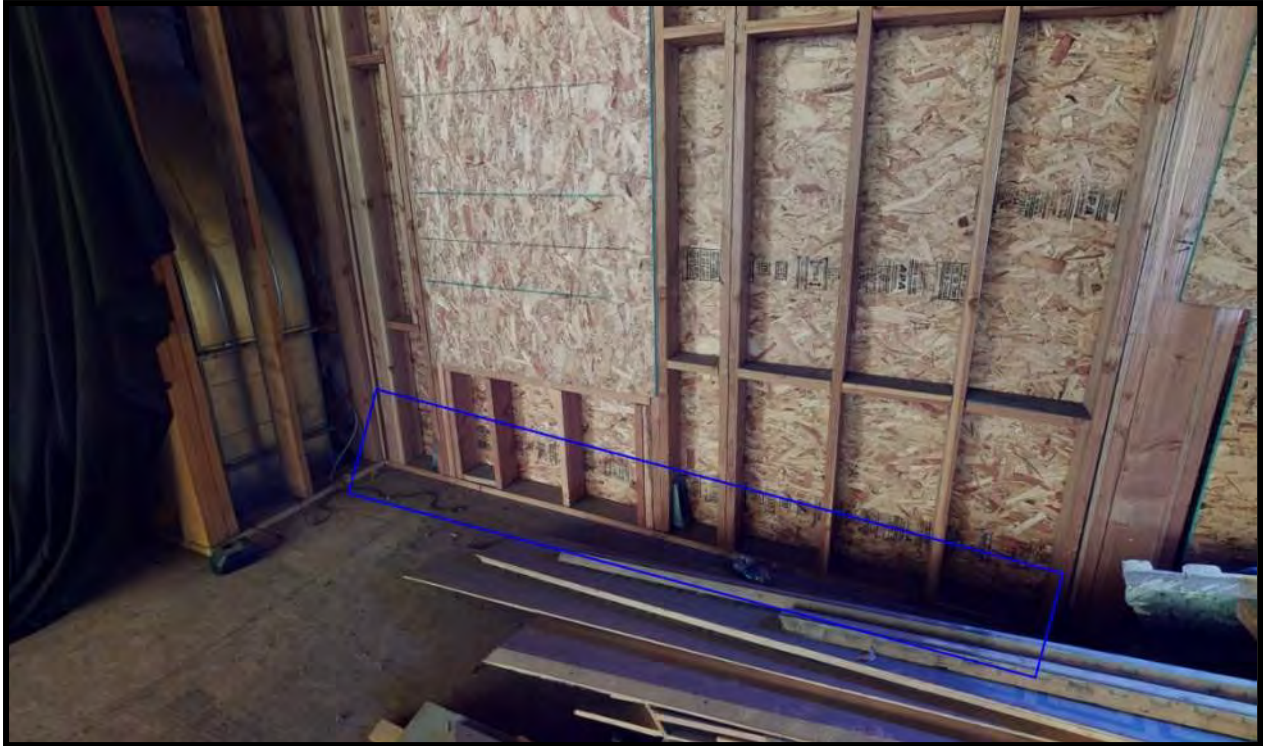
In addition to the minor cracking observed, Silman also noted that the shear walls all appear to be missing sill anchor bolts (see **Figure 28**). Should a lateral event occur, the walls would likely not be able to transfer the loads into the foundation, resulting in significant displacement. According to the 2002 Construction Drawings, 5/8" anchor bolts at 32" on-center or 16" on-center should have been installed.

Figure 28 View of missing sill bolts at the north wall of the stage.

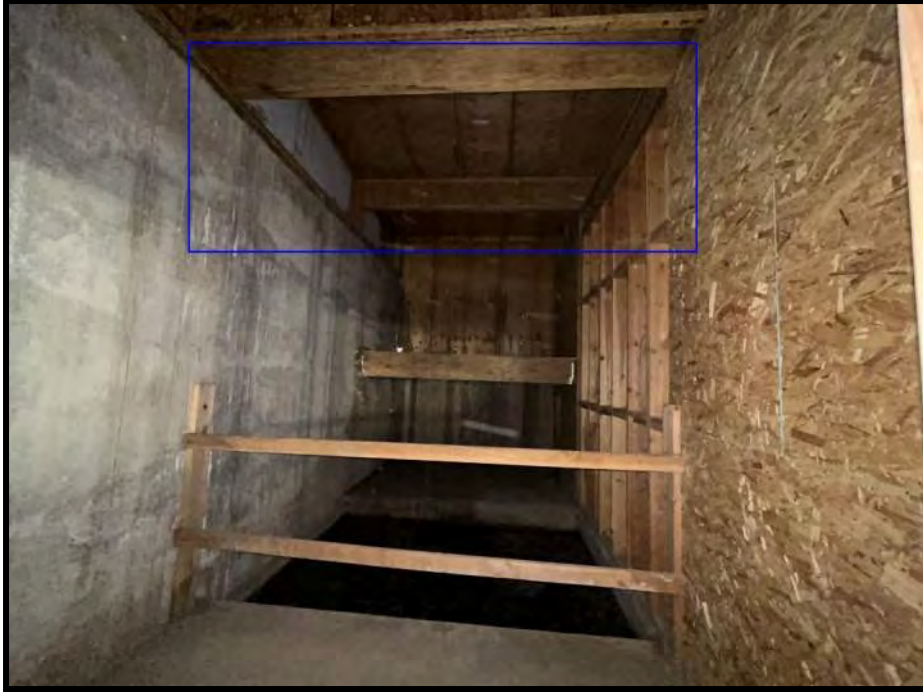
As mentioned in the Structural Description portion of the report, the west wing framing retrofits from 2002 were not completed. Instead, any new construction was mostly completed in the basement, and a sleeper floor was added over the first-floor framing (see **Figure 13**). Where there were openings in the first-floor framing for future elevators or stairs, the light sleeper floor framing is visible (see **Figure 29**). Note that this framing was not intended to be permanent. However, given that most of the floor framing was designed for higher floor loads, structurally the temporary framing is adequate and can continue to be used.

Figure 29 View of the light framing above the elevator pit in the basement.

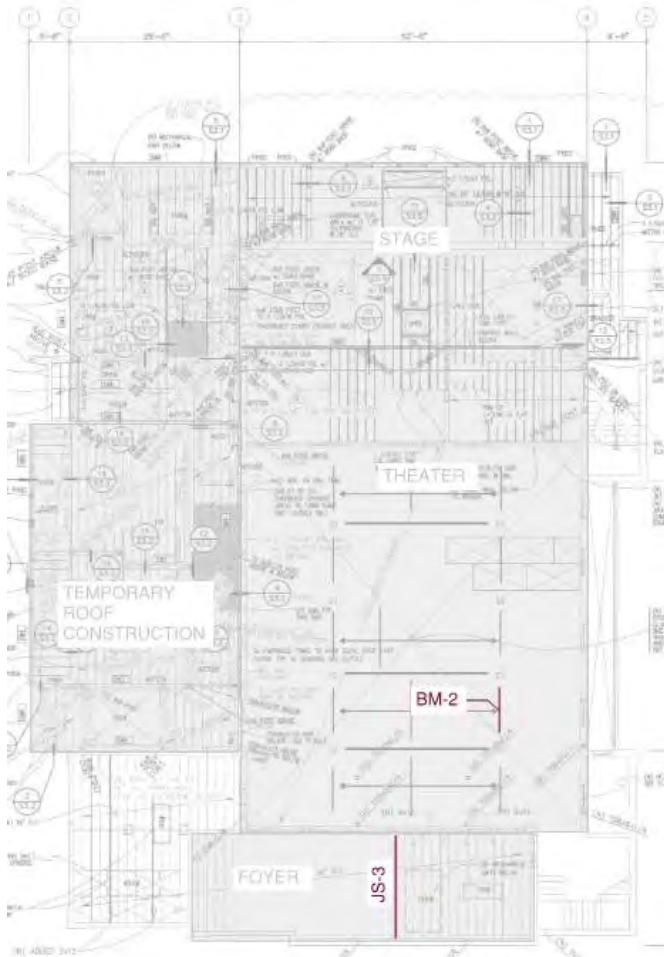
alone was applied. It is therefore likely that the material strength assumptions made for this analysis may not align with the actual properties of the wood material, or that the structure has not actually seen loads as large as those required by current code. Material testing is recommended to refine all analysis results, otherwise some reinforcing may be required to strengthen these members.

Figure 33 First floor plan highlighting the members that do not have sufficient capacity.
