DATE: December 2, 2024
TO: Council
THROUGH: Jackie Bryant, Interim City Manager
FROM: Ashley D. Turney, Assistant City Manager
DEPT: Arts and Culture
SUBJECT: Lear Safety Assessment

Hazard Assessment Report

Property Address: 528 W. 1st Street, Reno, NV, 89503

Date: 11/19/2024

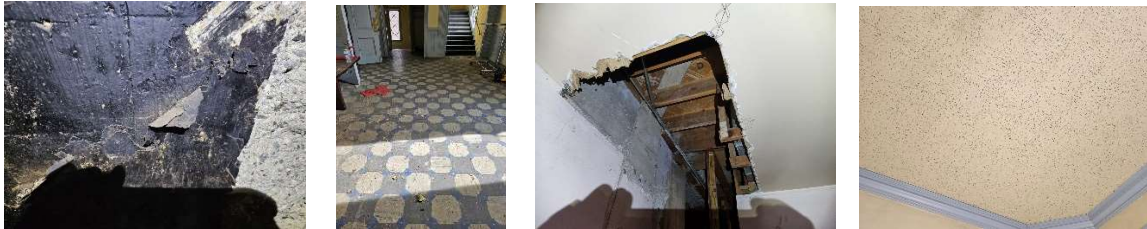
Finding 1: Presumed asbestos containing compounds

Narrative: Given the age of the building and various states of renovation, it must be presumed that asbestos containing material is present in the building. Presumed asbestos materials within the building include plaster, joint compound, floor tiles, ceiling tiles, and mastic. Many of these materials are in a degraded state, resulting in high friability of materials.

Corrective Action: No sampling data for asbestos could be found. It is recommended that sampling be performed to validate whether asbestos containing material is present in the structure.

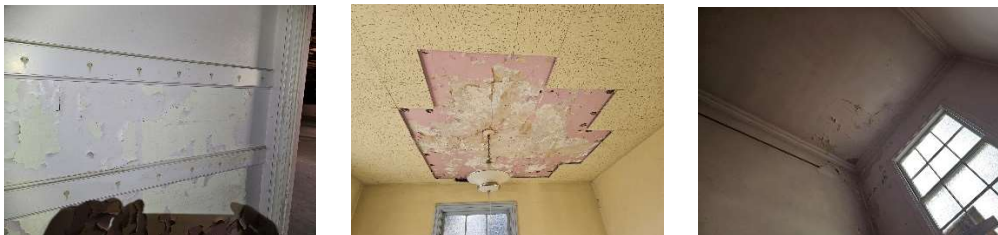
Finding 2: Presumed lead paint

Narrative: It must be presumed that lead containing paint is present in various areas throughout the building. Paint is spalling in numerous locations due to age and previous water infiltration. In its current observed state, low to moderate exposure risk is present. However given the numerous renovations which have occurred, the potential for lead bearing dust is elevated throughout the structure.

Corrective Action: No sampling data for lead could be found. It is recommended that sampling be performed to validate whether lead containing paint is present in the structure.

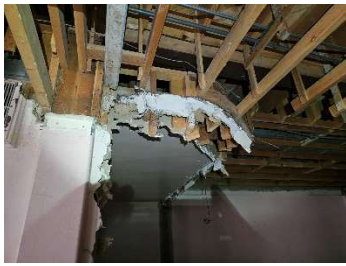
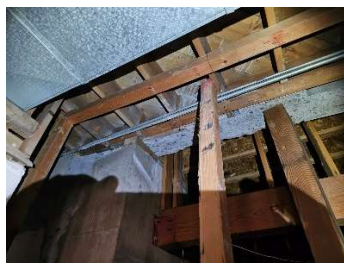
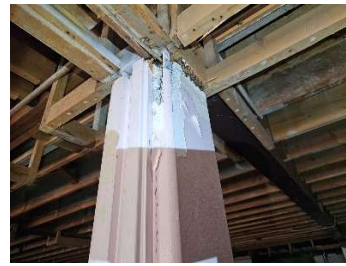
Finding 3: Structural stability

Narrative: Numerous floors and stairwells within the building experience deflection when walking on the surfaces. Inspection of the basement area indicates that numerous walls, including potential load bearing beams are no longer connected to trusses/joists.

Corrective Action: A structural survey should be performed by a qualified engineer to determine stability of above-basement floors.

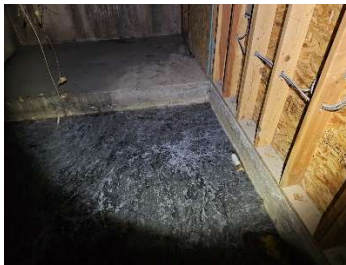
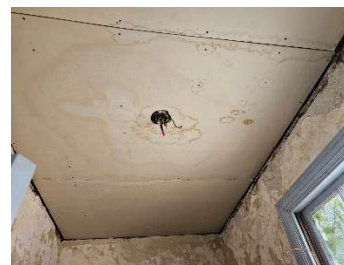
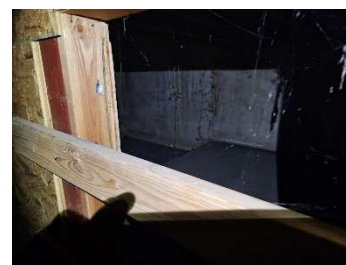
Finding 4: Water infiltration

Narrative: Evidence of water infiltration is present throughout the building. Standing water was identified in the basement of the structure in an abandoned elevator shaft. There is a high likelihood of mold present in the building, with visible biological growth in areas of standing water.

Corrective Actions: It is recommended that air sampling be performed to test for the presence of mold within the building. Additionally, standing water should be treated and pumped from the abandoned shaft.

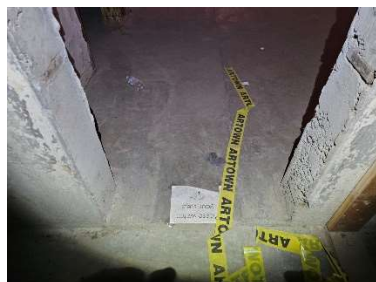
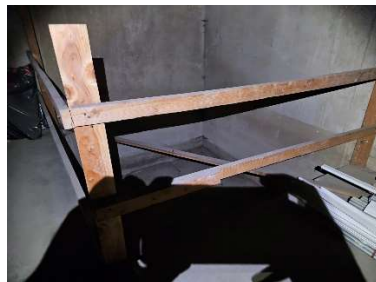
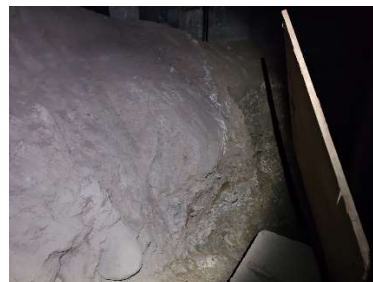
Finding 7: Fall hazards

Narrative: Uneven floors are present throughout the building. Structural instability in floors and stairwells may also result in a fall to lower level. Two abandoned elevator shafts are present in the building. One pit is guarded by lumber railing, however it is unclear whether this railing meets the strength requirements as it has not been maintained since installation. The other shaft is unprotected.

Corrective Action: Unless it is the intent to reinstall elevators in the structure, it is recommended these pits be filled with concrete or other material to mitigate potential fall hazards. In the absence of filling, protective railing (meeting requirements under 29 CFR 1910, Subpart D) should be erected. Floor transitions should be placed where floors of differing heights meet.
