COCHRANE DITCH SURVEY - DECEMBER 2003  
STEAMBOAT DITCH SURVEY - DECEMBER 2003

**Gray & Associates** INC.  
CIVIL ENGINEERS • PLANNERS • SURVEYORS  
130 VINE STREET  
RENO, NEVADA 89503

December 2, 2003

## **City of Reno Irrigation Ditch Assessment Program**

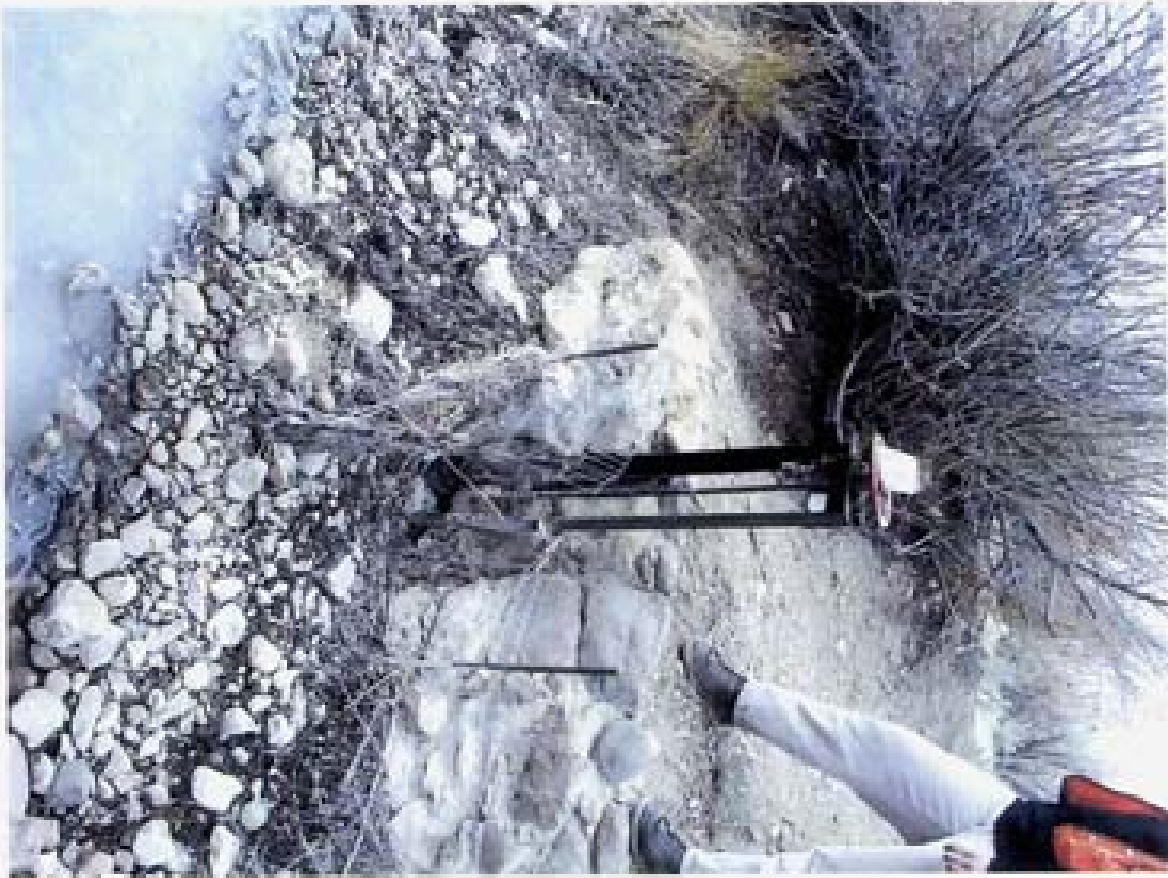
STEAMBOAT 1044

1044	1	Erosion	Construct cutoff wall upstream of drop Stabilize vertical face with concrete or masonry wall Construct splash pad in flowline
1048	1	12" RCP	Construct headwall and rip-rap to flowline
1050	1	24" RCP	Repair undermined/separated pipe sections, construct headwall and rip-rap to flowline of ditch, construct curb on existing access road from Ashfork to route surface drainage into existing drop inlet at east end of access road
1051	4		Rip-rap to flowline of ditch
1053	5	(Southampton) 12" RCP side of box	None
1055	RCB	(Southampton) Outlet end	Rip-rap to flowline of ditch
1056	4	Wash from S. Hampton.	Monitor future upstream development to ensure that steps are taken to minimize erosion at this location
1057	5	(Meridian) upstream 12" entering Box	None
1059	5	(Meridian) downstream	None
1076	1	Susileen at Markridge	Construct headwall and rip-rap to flowline
1077	4		Remove grout and rip-rap to flowline

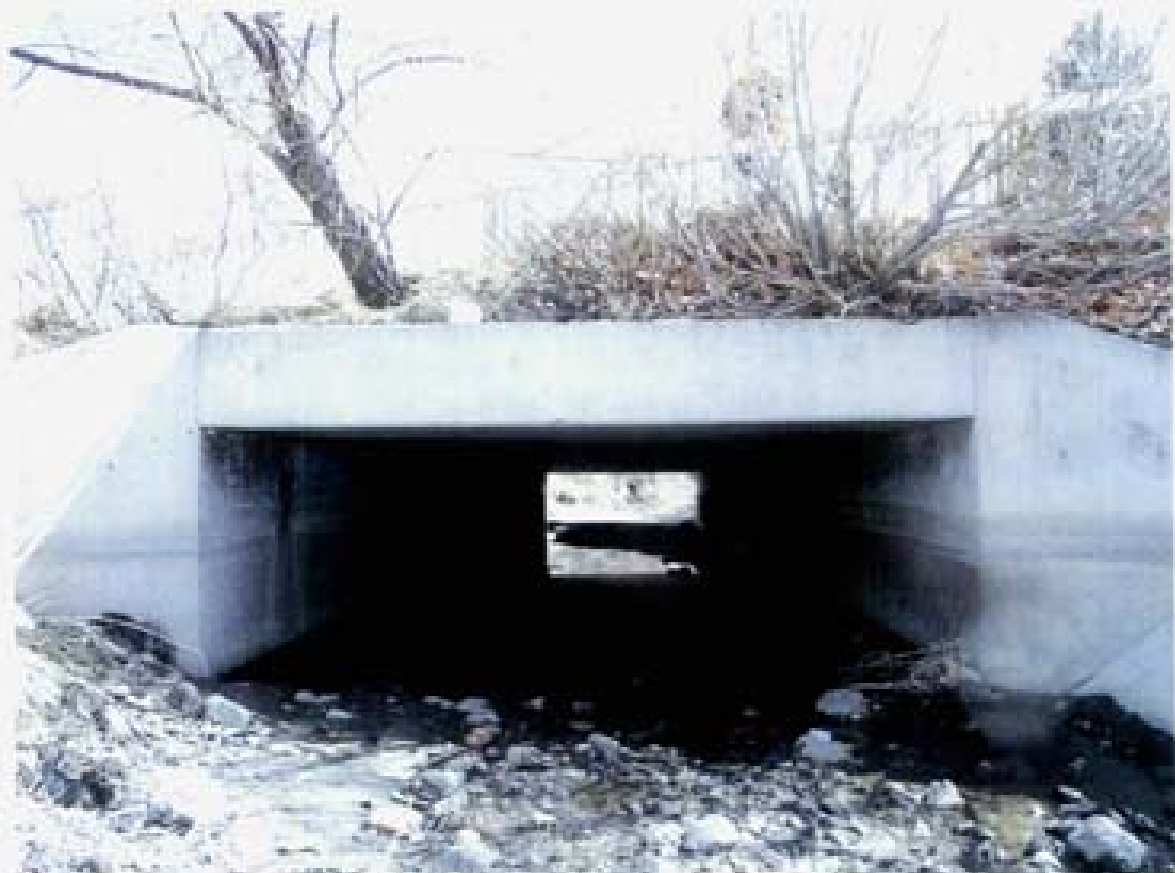
STEAMBOAT 1107

1104	5	Headwall 10'	None
1106	4	12" steel pipe overcrossing ditch	Repair failing pipe anchorages
1107	3	Ditch enters 1' above I.E.	Rip-rap to flowline of ditch
1108	5	No inlets	None
1109	5	No inlets	None
1111	5	BM 2410	None
1112	2	Drainage from above	Construct cutoff wall in flowline above drop Construct concrete or masonry wall to stabilize Construct splash pad in flowline
1116	1	Exposed sanitary sewer pipe over ditch	Construct concrete or masonry wall to stabilize Backfill over exposed pipe
1127	5	CL 18' Box Culvert	None
1130	5	CL 18' Box Culvert	None
1134	3	Run off from tank site	Rip-rap to flowline of ditch
1140	5	(Skyline) No inlets	None
1141	4	Bridge over Ditch	Rip-rap sides of ditch
1142	5	Bridge over Ditch	None
1143	1	12" PVC down drain from Cuesta Apts.	Hydraulic analysis required. Major erosion due to overtopping of ex. DI at top of slope. No apparent source of surface runoff to ex. DI indicates that erosion is due to surcharging of upstream storm drain causing discharge from ex. DI.

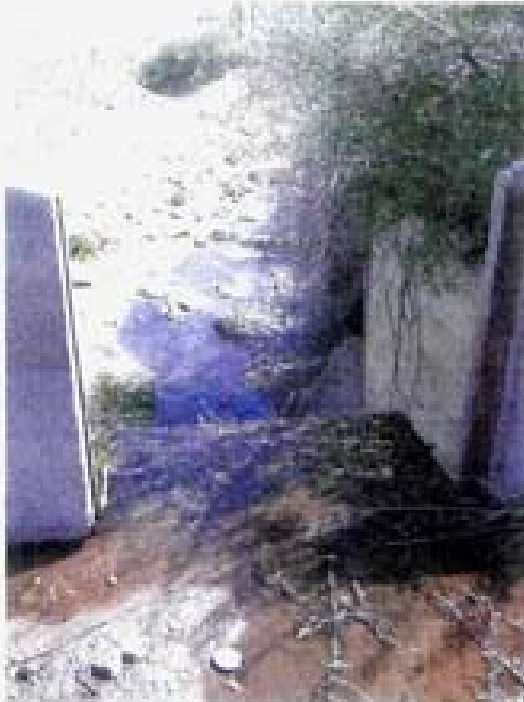
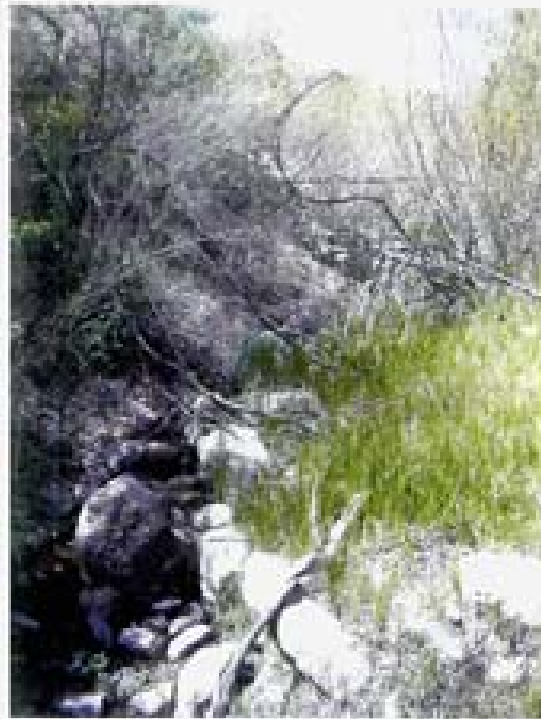
Point 17. At this point, a small creek crosses under the Steamboat Ditch. The Photo on the left is a view of the Ditch from upstream. The photo on the right is a view standing in the ditch looking downstream (south).

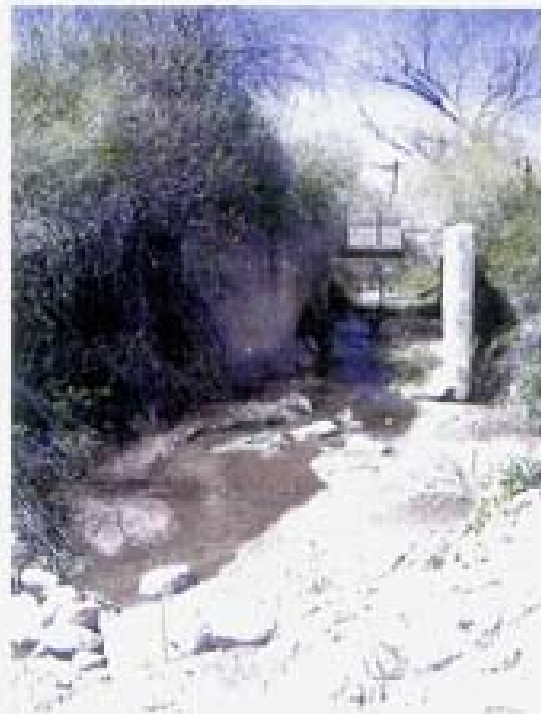
Point 17 cont. The above photo look downstream from the Steamboat Ditch crossing towards the creek. Note that the boards have not been placed back in the Ditch. The upper right photo is a view looking upstream at the creek (from up gradient of the ditch). The photo on the right is a view looking upstream at the creek and the Steamboat Ditch crossing. No large undercutting or instabilities were noted.

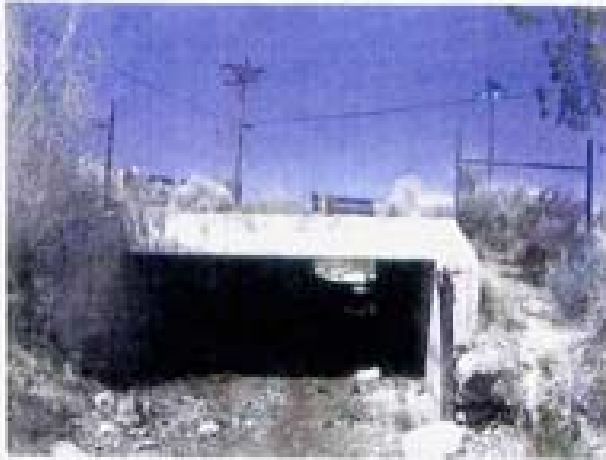
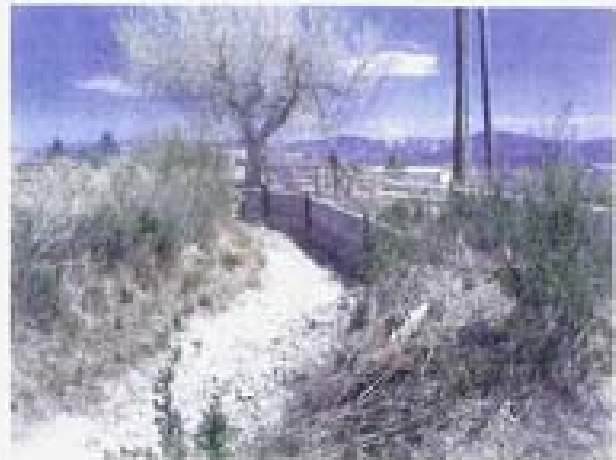
Point 18. Box culvert located at the intersection of Lone Tree Lane and Bell Haven Road. There is sluice gate on the right hand side of the photo.

Point 19. Concrete support structure at a bend in the Steamboat Ditch.

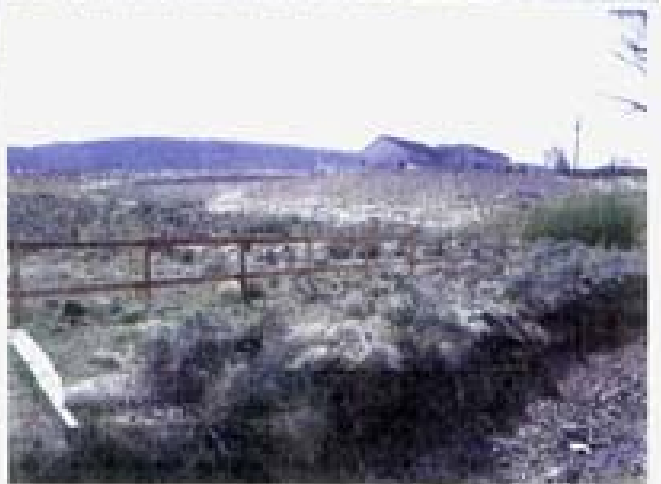
Point 30. A drainage area enters into the Steamboat Ditch at a point marked by rip-rap. The basin is expected to convey a large amount of stormwater as indicated by the double boxed culvert upgradient of the Ditch.

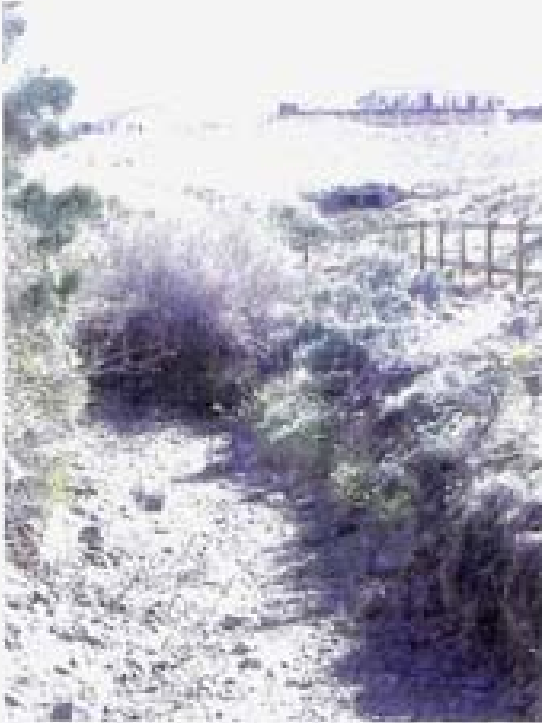
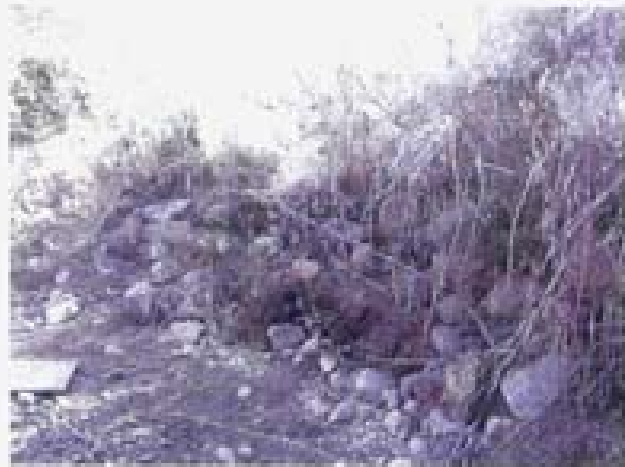
Point 31. The double box culvert indicates that a large volume of stormwater runoff is expected for this area. However, no clearly defined entrance point was noted (see above photo).

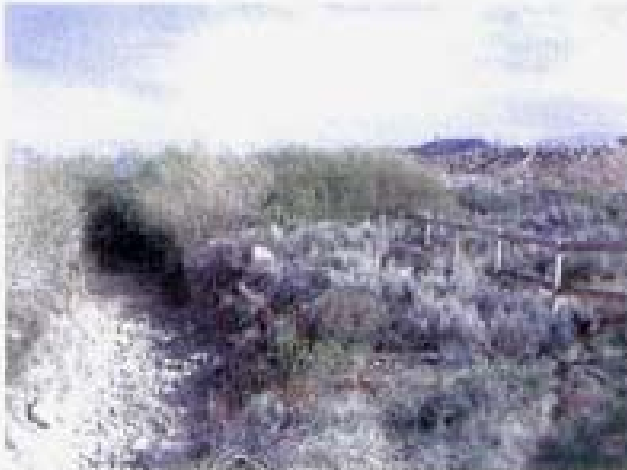
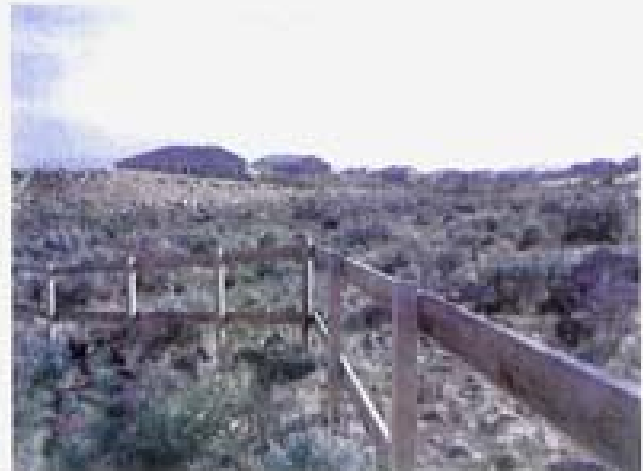
Point 32. The area along this section of the Steamboat Ditch was thick with vegetation. The local topography indicates that storm events should provide the Steamboat Ditch with flows, however, no clearly defined channel was noted.

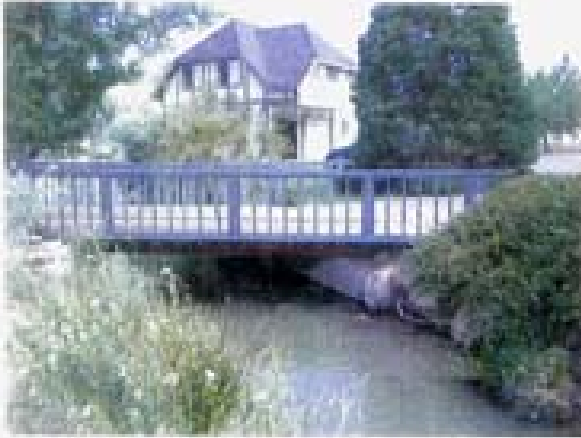
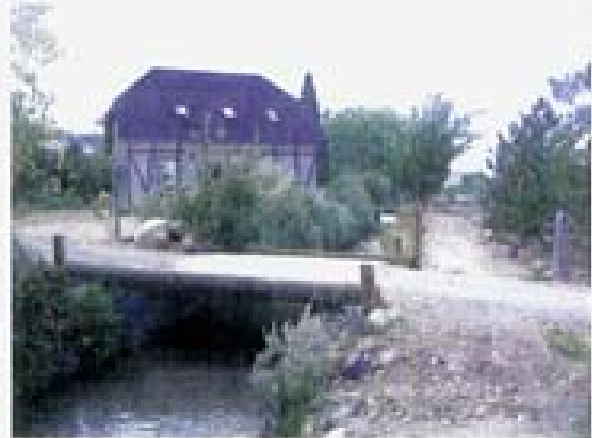
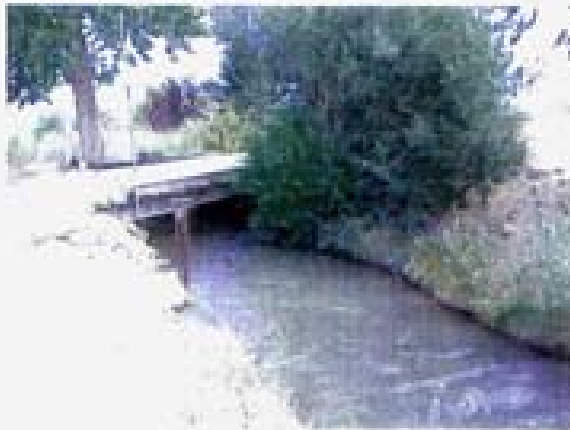
Point 33. Three small bridges crossing the Steamboat Ditch along private properties located on Vincent Lane.
