HISTORIC STRUCTURE REPORT

Lear Theater

City of Reno | October 18, 2024

Lear Theater Structural Condition Assessment

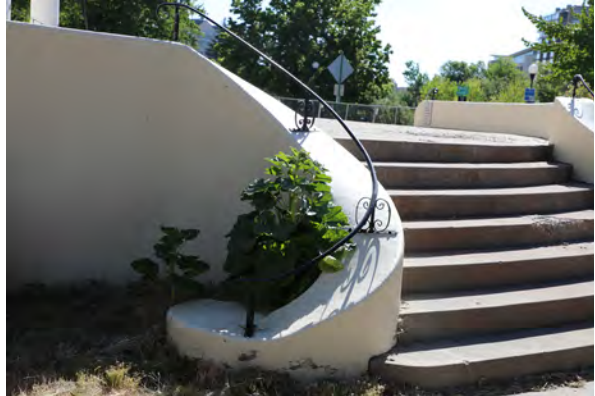
Figure 02: Non-compliant handrails at the southwest stair

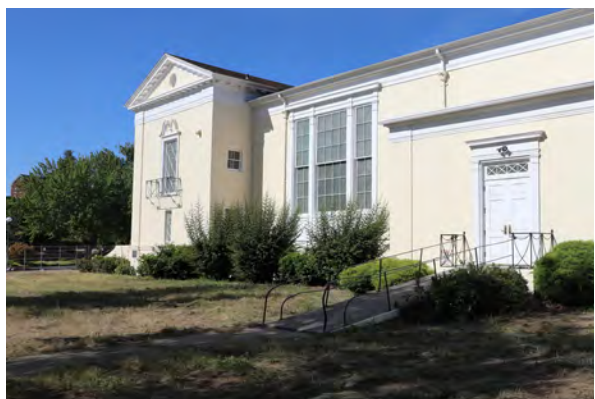
Figure 06: Non-compliant ramp and sidewalk overgrown with vegetation at the east entry

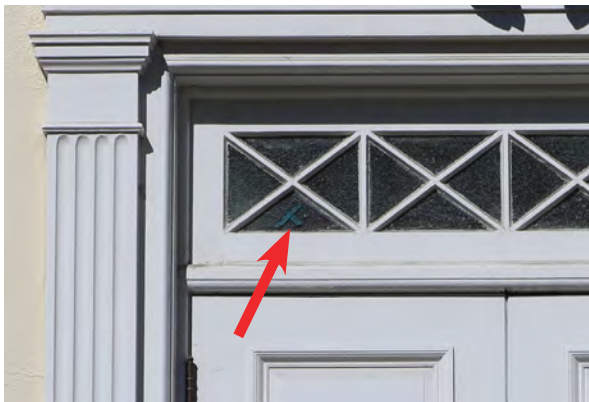
Figure 14: Cracked glazing at east entry transom

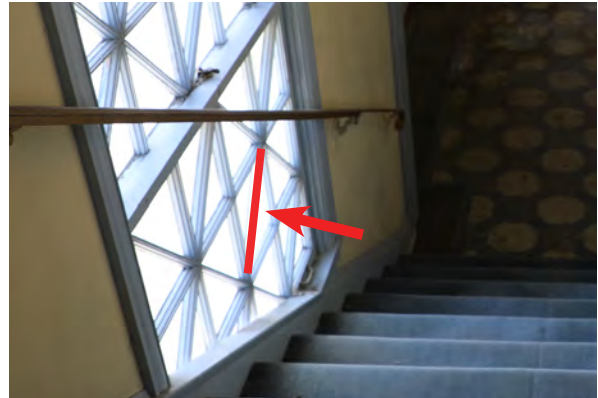
Figure 16: Missing interior muntin at Window 1-12

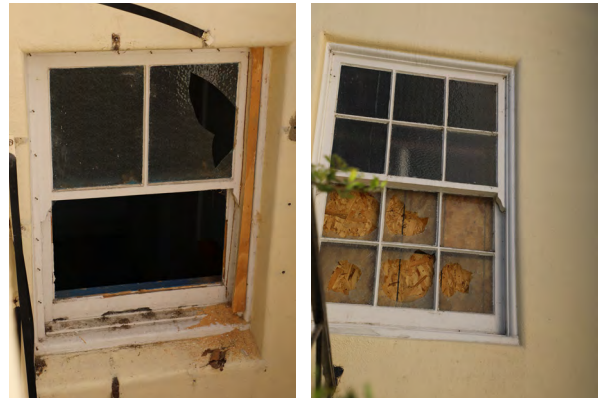
Figure 17: Damaged sash and broken or missing glazing at Windows 0-10 (left) and 1-10 (right)

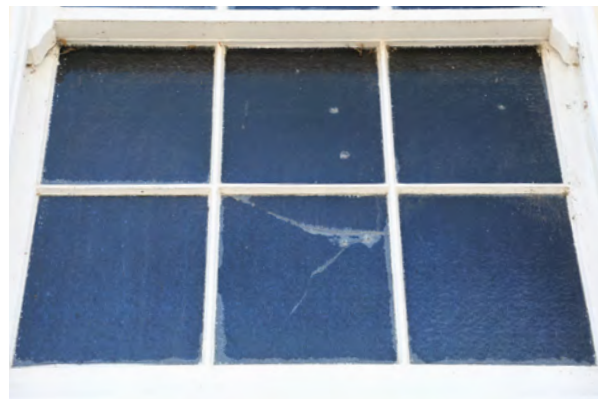
Figure 18: Damaged glazing at Window 1-01 on the north wall

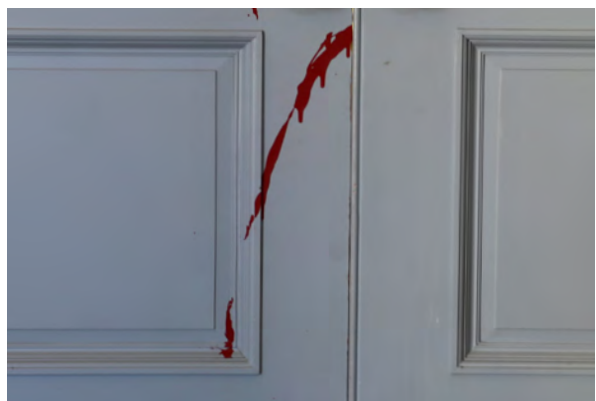
Two paired three-paneled wood doors connect the Foyer to the Auditorium. These doors are generally in good condition with light scuffs and minor paint failure at the bottom edges. The east pair of doors have some red paint on the west door. The doors have brass doorknobs at the Foyer side and push plates at the Auditorium side.

Figure 24: Red paint on Door 1-08 in the Foyer, Room 101

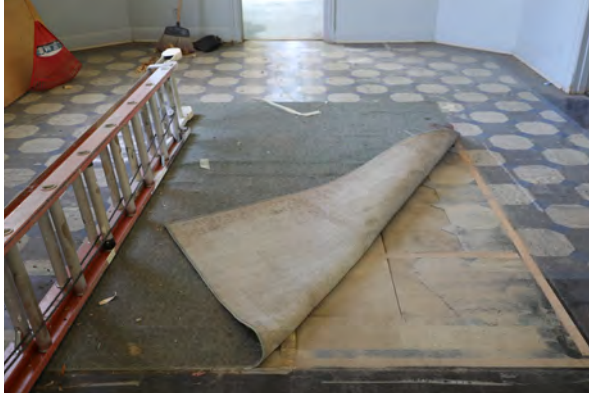
Figure 31: Fire damaged and missing vinyl tile under a temporary carpet section in the west Lobby (Room 115)

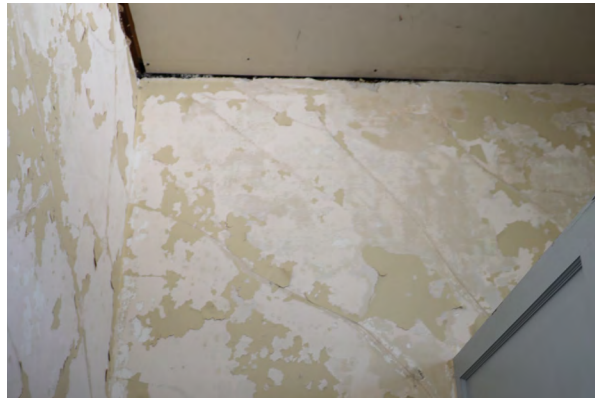
Throughout most of the building, the plaster finish is in fair to poor condition. There is extensive cracking and visible signs of smoke damage or general staining throughout. Although the painted wood trim and wainscot are generally in good condition where installed, some portions of the extant wainscot are unpainted where the original radiators were removed. The painted plaster finish in the Women's Restroom (Room 112) is significantly damaged, likely due to the removal of ivy growth, which caused extensive damage

Figure 35: Severely damaged paint finish and plaster, possibly caused by ivy removal in the west Women's Restroom (Room 112)

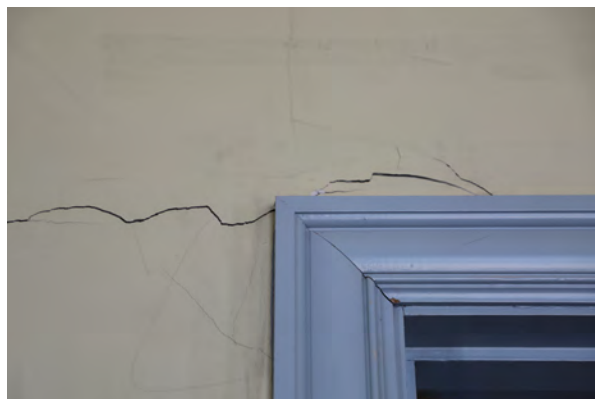
Figure 36: Significant cracking of plaster at cased opening on the north wall of west Lobby (Room 115)

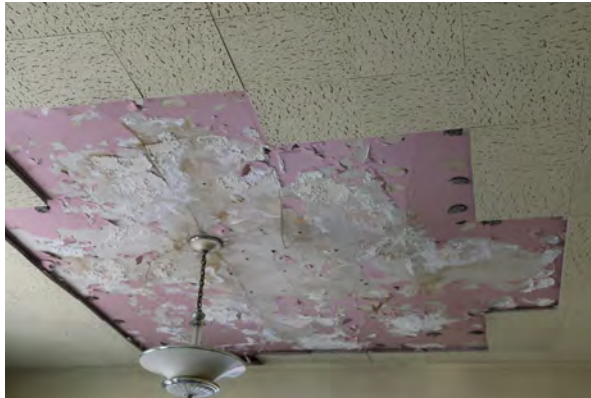
Figure 37: Missing acoustic tile and damaged historic finish at ceiling of the Literature Room (Room 114)

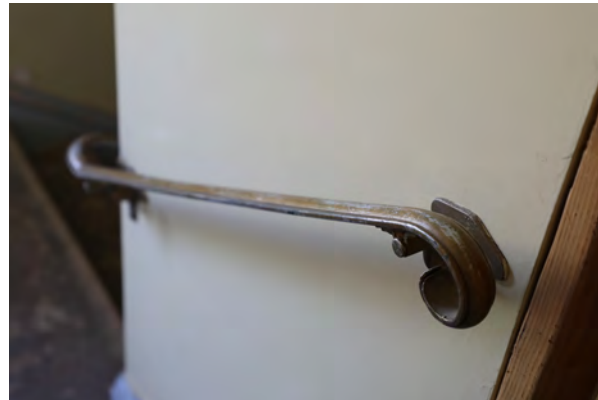
Figure 40: Stair handrails lack ADA compliant extensions, and are not at the proper height

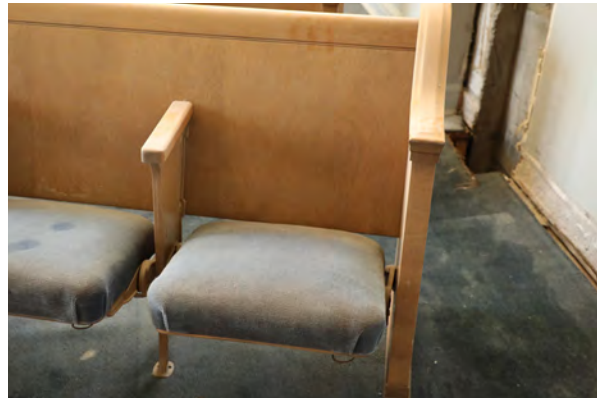
Figure 41: Accumulation of dust and dirt on theater seating upholstery in the Auditorium (Room 107)

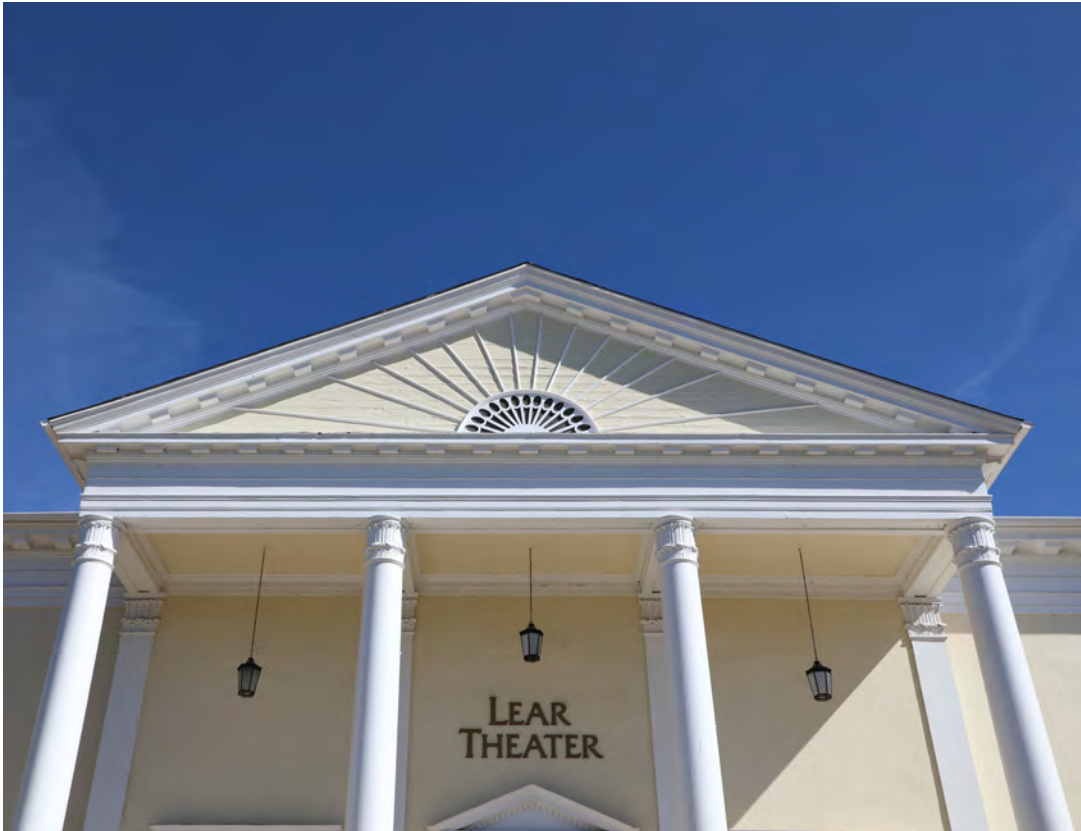
Figure 03 - Gable end at primary (south) façade, view north(ARG, 2024)

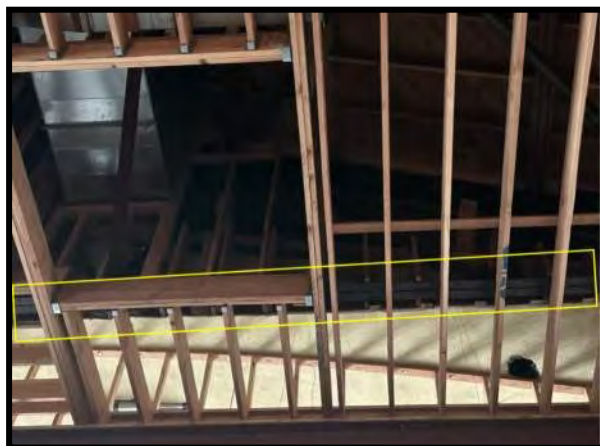
Figure 15 Exposed base of roof truss from Stage.

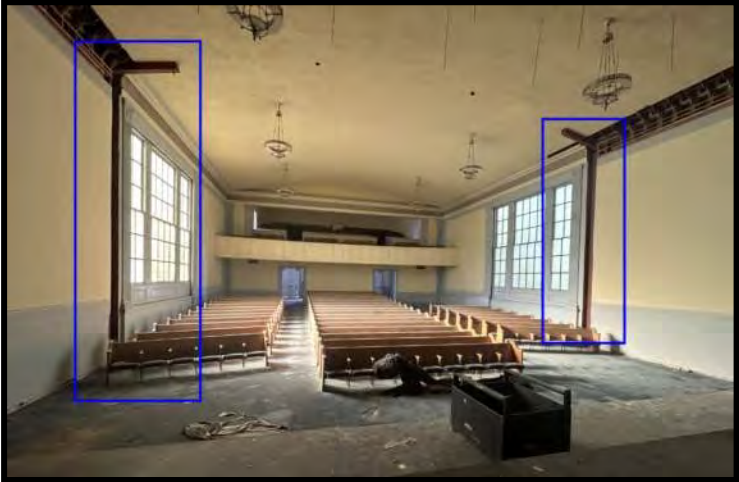
Additional steel framing was added to the walls and roof in 2002. Initially it was not clear whether this framing supported lighting equipment or served as part of the lateral system. Based on the 2002 Construction Drawings, it appears the north-most truss was added to help support the existing roof due to the reconstruction of the north extension (see **Figure 17**). The framing added at the east and west of the stage appears to support gravity loads from the wall above new openings, or planned openings. All other steel, including the exposed steel TS7x7x1/4 columns, is shown on the 2002 Lighting and Hoist Framing Plan, and was intended to support gravity loads from the stage lighting system (see **Figure 18** and **Figure 19** below).

Figure 19 View of the steel TS7x7x1/4 columns from the stage.

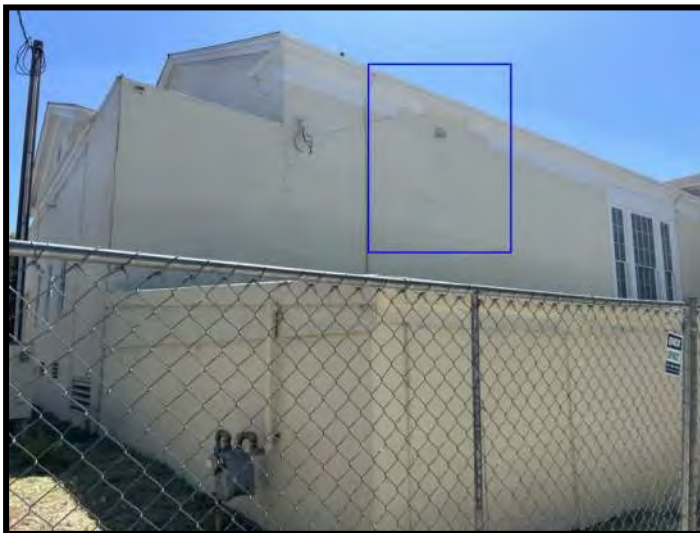
In addition to the temporary floor framing, it appears some of the west exterior wall was temporarily enclosed in a plastic membrane. While on-site, Silman noted this membrane is bubbling as shown in **Figure 30**.

Figure 30 View of bubbling plastic membrane at the west exterior wall.

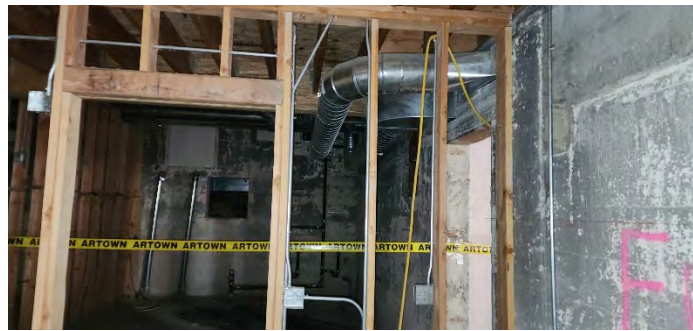
Existing ductwork in basement:

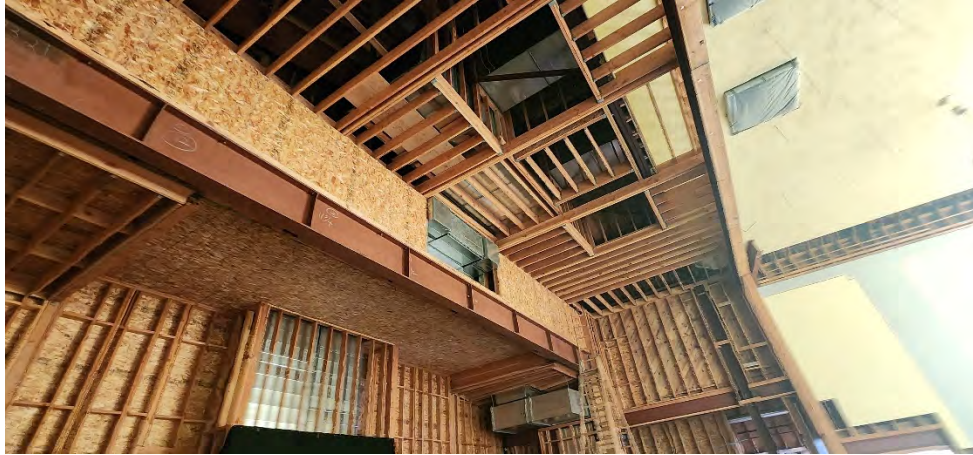
Existing ductwork at existing stage and auditorium ceiling:

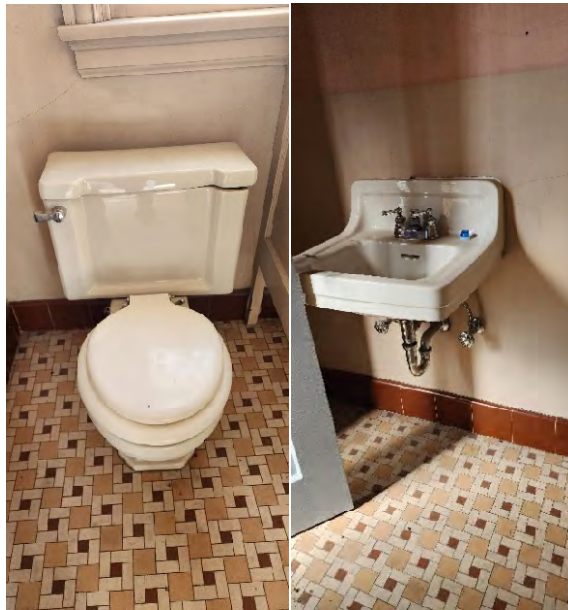
Existing toilet room fixtures:

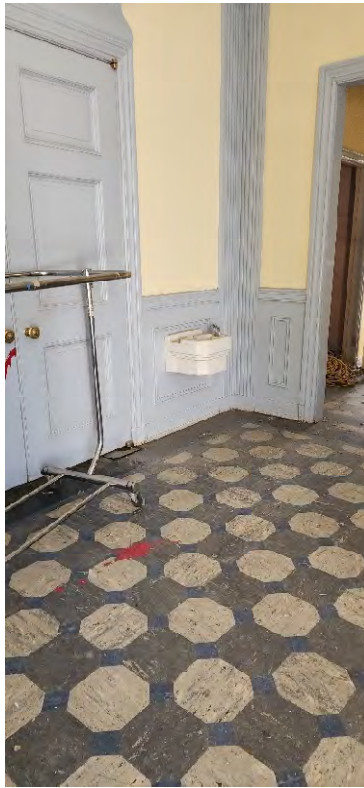
Existing drinking fountain at entry vestibule

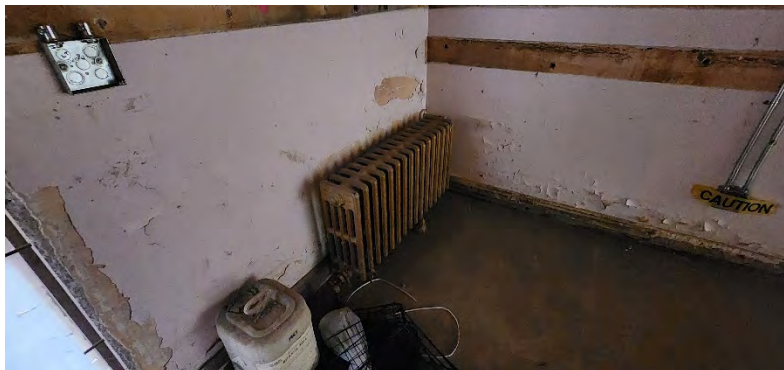
Old steam radiator:

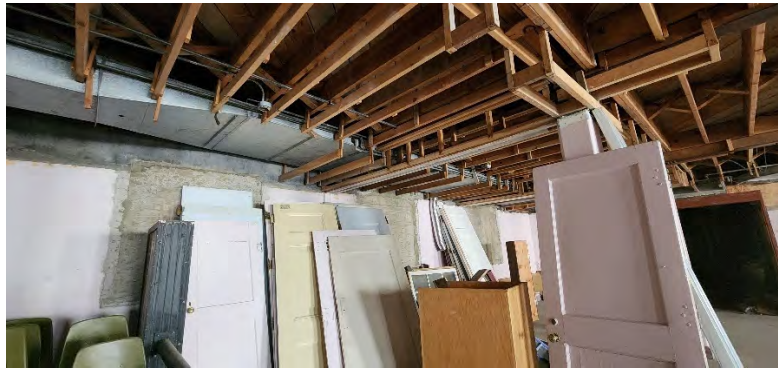
Circa 1934 existing ductwork:
