HISTORIC STRUCTURE REPORT

Lear Theater

City of Reno | October 18, 2024

Lear Theater Structural Condition Assessment

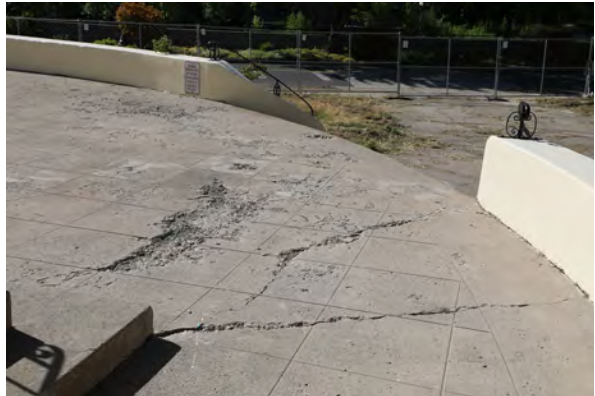
Figure 04: Significant spalling of the concrete of the south entrance Terrace

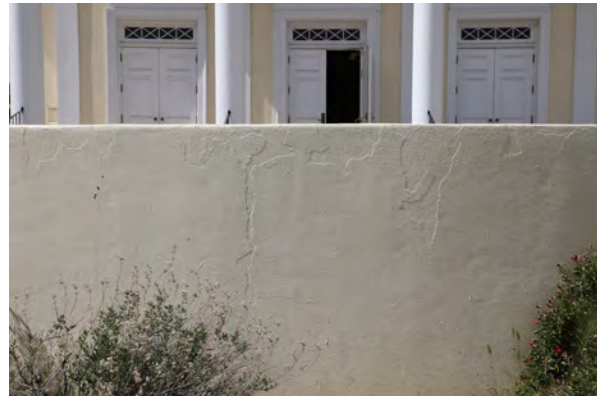
Figure 08: Paint loss telegraphing through new paint coating at south face of the south terrace

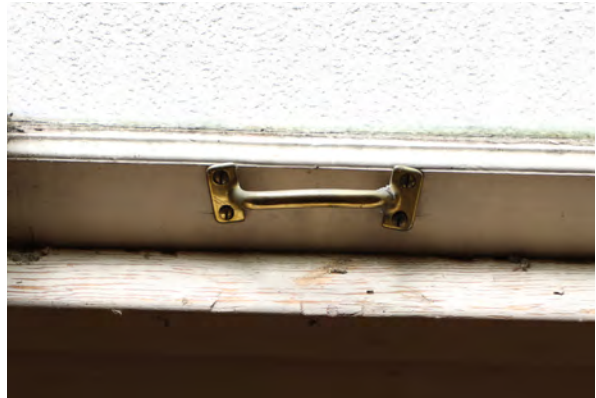
Figure 22: Damaged (bent) hardware at Window 2-04 in the Committee Room (Room 204)

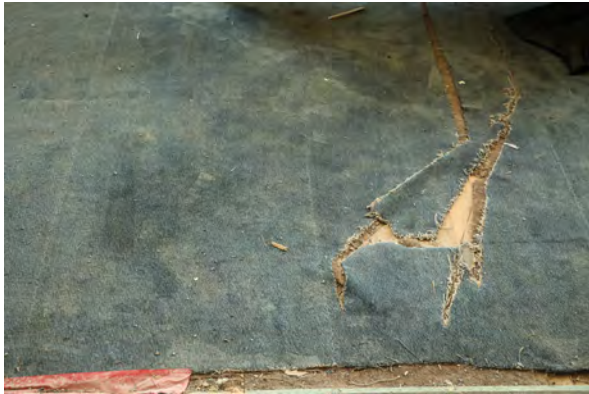
Figure 32: Damaged and worn broadloom carpet in Auditorium (Room 107)

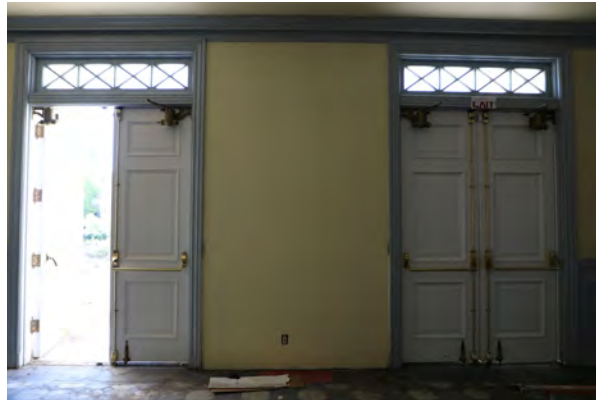
The painted plaster finish in the Foyer is generally in good condition, though there is some paint splatter on the north wall and a portion of the painted, paneled wood wainscot is missing along the south wall. The walls of the Auditorium are similarly in good condition where extant, with much of the decorative painting intact. However, during the 2002 renovations, some of the interior wall finishes were removed from the Auditorium, Stage, and east Entry, leaving them in a partial state of completion with only framing installed. While some original decorative wood trim was removed during these renovations, it was salvaged and is currently stored in the backstage area.

Figure 34: Missing wainscot between Door 1-14 and Door 1-15 in the Foyer (Room 101)

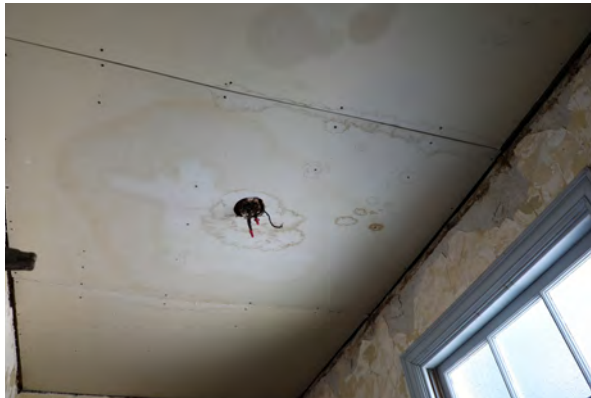
Figure 38: Moisture damage, unfinished drywall, and removed light fixture at ceiling of west Women's Restroom (Room 112)

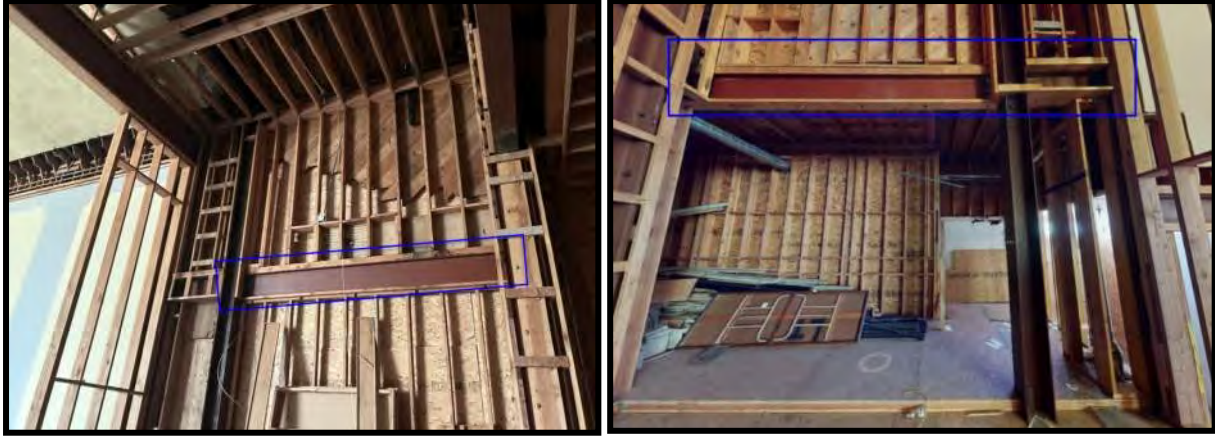
Additional steel framing was added to the walls and roof in 2002. Initially it was not clear whether this framing supported lighting equipment or served as part of the lateral system. Based on the 2002 Construction Drawings, it appears the north-most truss was added to help support the existing roof due to the reconstruction of the north extension (see **Figure 17**). The framing added at the east and west of the stage appears to support gravity loads from the wall above new openings, or planned openings. All other steel, including the exposed steel TS7x7x1/4 columns, is shown on the 2002 Lighting and Hoist Framing Plan, and was intended to support gravity loads from the stage lighting system (see **Figure 18** and **Figure 19** below).

Figure 18 View of west (left) and east (right) steel framing above the stage.

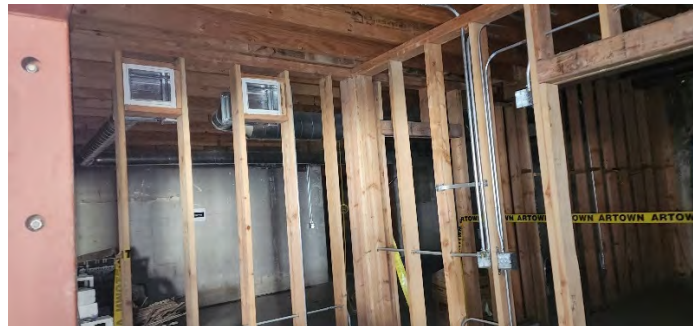
Existing ductwork in basement:

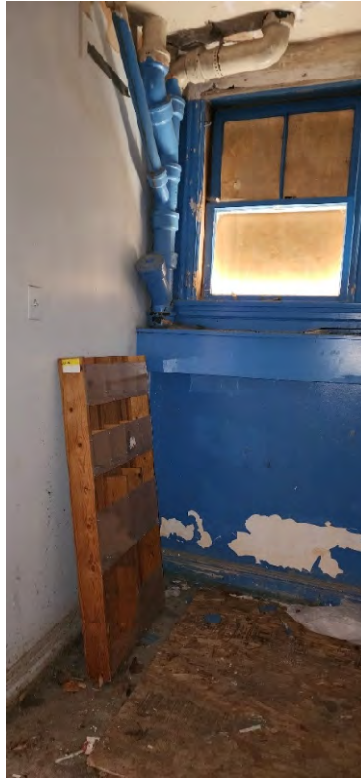
Existing waste system in basement and below existing stairwell toilet room:

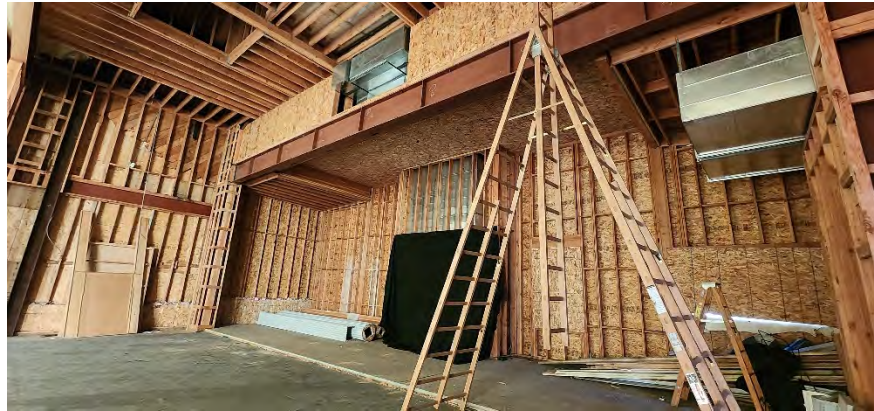
Existing ductwork at existing stage:

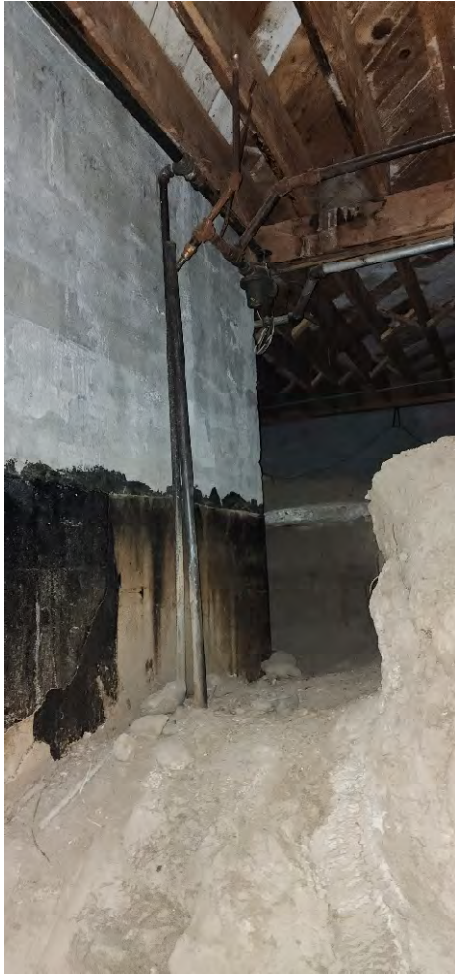
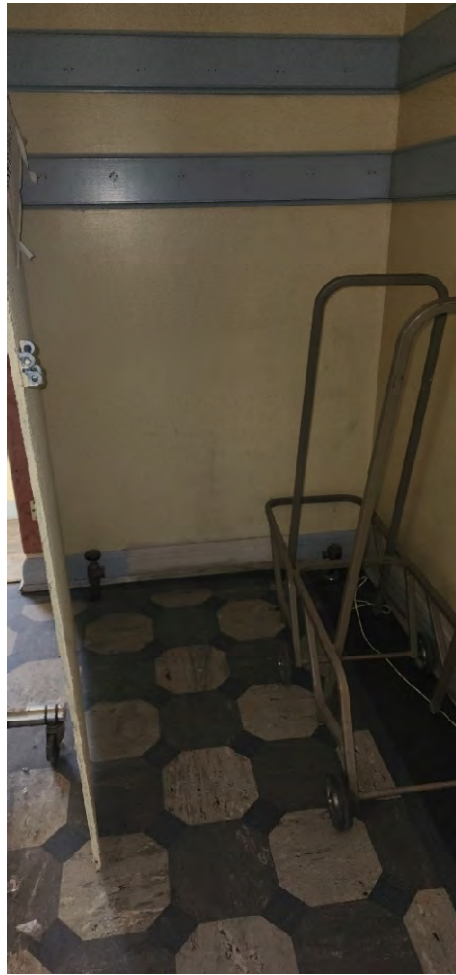
Abandoned steam piping:

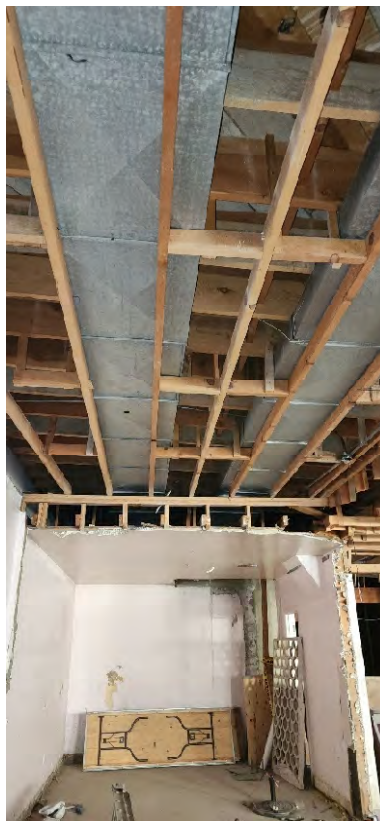
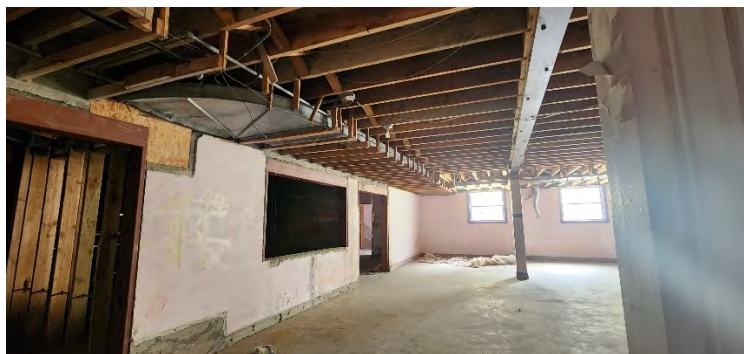
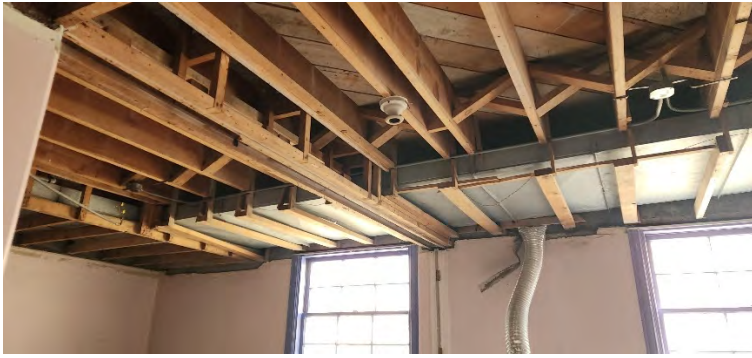
Circa 1934 existing ductwork:

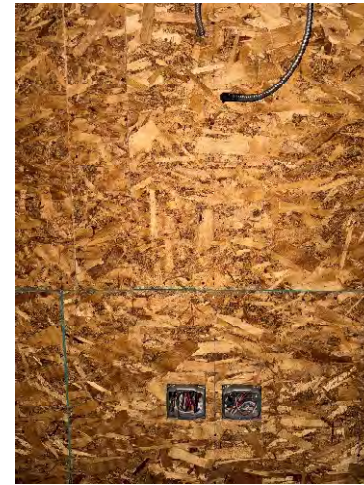
Infrastructure for new circuits was added in the recent past, based on a project prior to 2002.

Photo	Description
Photo 1	NV Energy Utility Pole Mounted Transformer
Photo 2	Metered Pedestal
Photo 3	Metered Pedestal Breaker
Photo 4	Mechanical Disconnects & Gutter
Photo 5	15A Receptacle
Photo 6	New Infrastructure Electrical Boxes

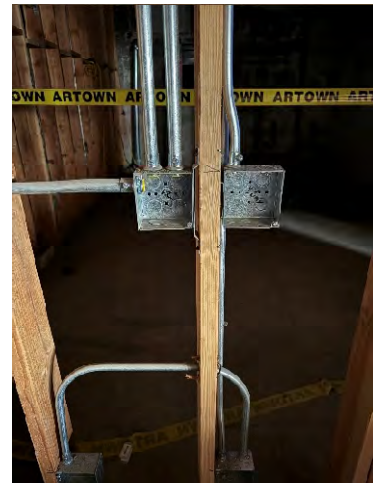
Infrastructure for new switches was added in the recent past, based on a project prior to 2002.

Photo	Description
Photo 7	Balcony Pendant Lights
Photo 8	Manual Toggle Switch
Photo 9	New Infrastructure Electrical Boxes
Photo 10	Lighting Control Panel, Time Clock, & Switches
Photo 11	Time Clock
Photo 12	Exit Sign Placard with No Power
Photo 13	Portico Pendant Lights
Photo 14	Exterior Flood Lights
Photo 15	Exterior Wall pack
